Doc. No. D627-005-P01

#### INDEPENDENT REVIEW OF THE REFURBISHMENT PROPOSALS FOR THE NORTH RIVER TUNNEL REHABILITATION PROJECT, NEW YORK

**BY LONDON BRIDGE ASSOCIATES**

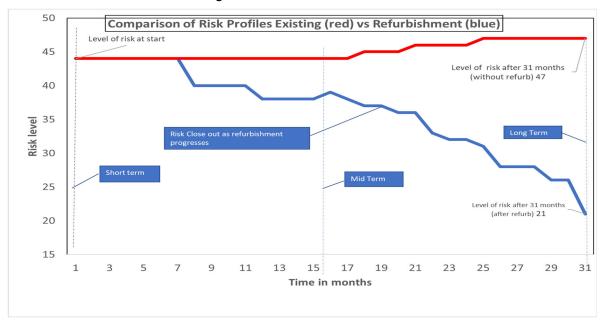
Figure 2-1: Comparison of Risk Profiles Existing vs Refurbishment

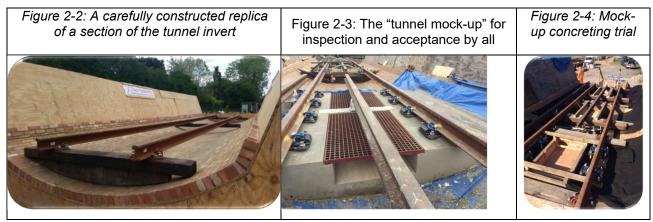
The photographs below are examples of the mock-up of the Baker Street to Finchley Road London Underground (UK) Renewal:

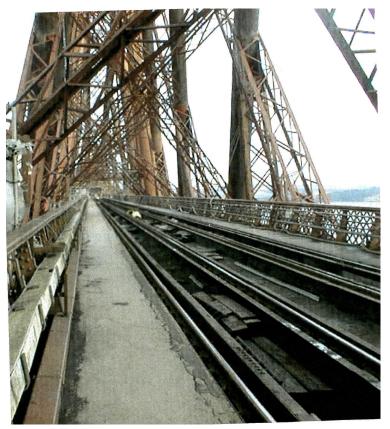
Figure 9-1: Guard rail

In the UK and elsewhere in Europe it is common practice to install "anti-derailment rails" or "guard rails" along the complete length of track crossing vulnerable bridges and viaducts. The guard rails are arranged to provide, in effect, a flangeway inside each of the running rails with a clear width of 3.75" (95mm). This is much larger than the 1.75" (44mm) flangeway provided at switches.

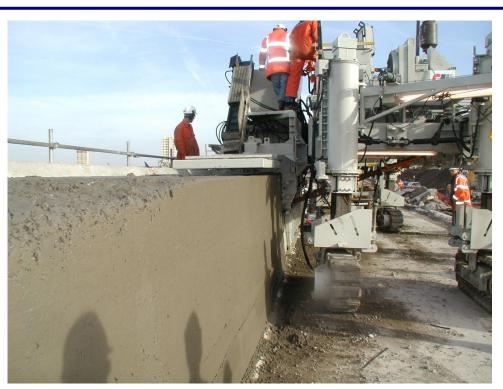
Figure 10-3: Mock-up built to trial method and develop concrete mix and concrete finish for Slipform paved Haunches for HS1 London Tunnels Alliance

- v. A section of an NRT tube could be identified to carry out a "Pilot" study to test the planned method and equipment. This type of study would be subjected to the same rigours of planning and risk management as the main works and used to inform the future construction methodology.

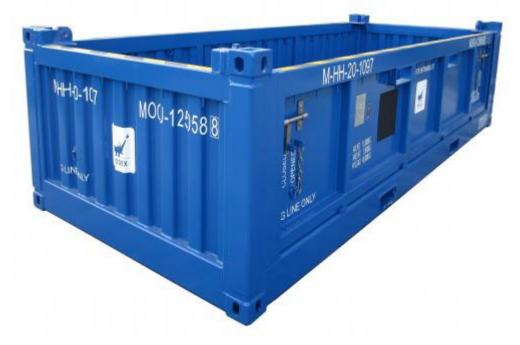
These containers, which are made mostly of steel, are half the height of full-sized containers. They are used especially for coal, stones etc., which need easy loading and unloading.

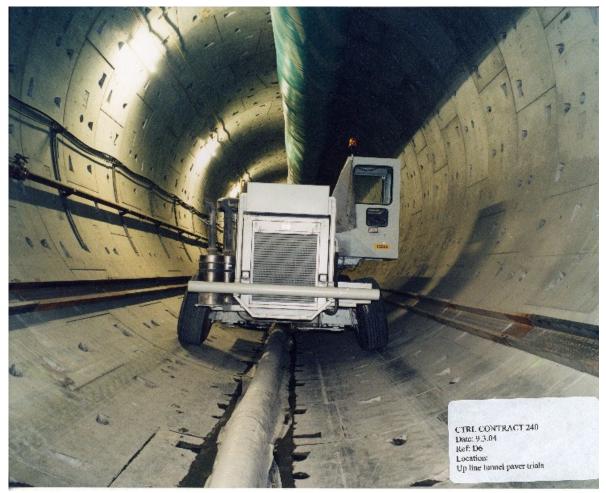
*Figure A6.1 Gomaco paver getting ready to provide stage 1 track bed on High Speed 1 in the UK*

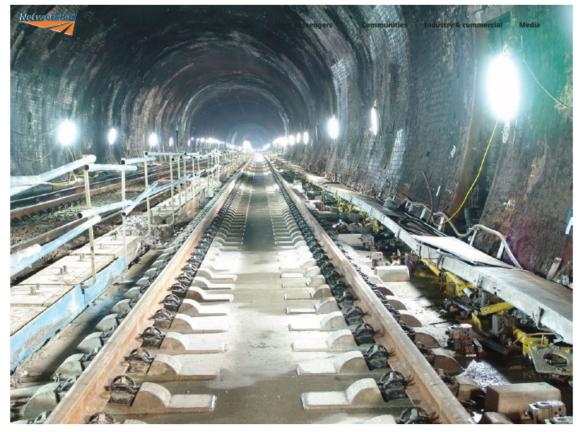
Southampton Tunnel, UK, during 12-day outage to install 1600 ft long slab-track.

During the development of the slab-track scheme for the 1584 feet long (483 metres) Southampton Tunnel, to enable 9'-6" containers to move by rail to the Port of Southampton in the UK, a 3D "wire-frame" drawing and 2D composite of a series of cross-section surveys of Southampton Tunnel were produced from 3D laser survey data. Copies of these drawings are below for information. The deformation of this tunnel over its 160-year life can be clearly seen, together with a length of tunnel where a partial collapse was caused by water trapped in an abandoned early 19<sup>th</sup> century canal tunnel that ran alongside the "newer" railway tunnel. The failed length, sections 35 to 53 on the "wire frame" drawing, was made good using Cast Iron (CI) rings during the 1980s. At the time the 3D laser survey was made it was not possible to include points below ballast level. For the design, original cross-section drawings were over-laid to the survey drawings in order to develop the slab-track design which included breaking out parts of the original brick invert. A photograph of the interior of this tunnel, during construction of the south-westbound track-slab during the 12 day construction Christmas to New Year track outage in 2009-10, is appended; the CI ring length can be seen in the middle distance.

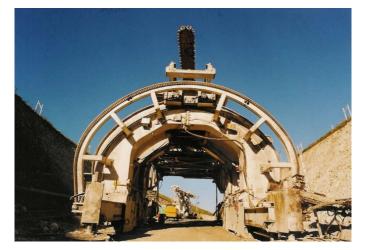
Figure A10.4: Pre vaulting tunnelling machine Ramsgate Port Access tunnel

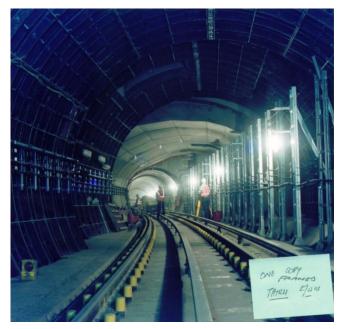
Figure A10.5: London Bridge Station Northern Line Link under the river Thames

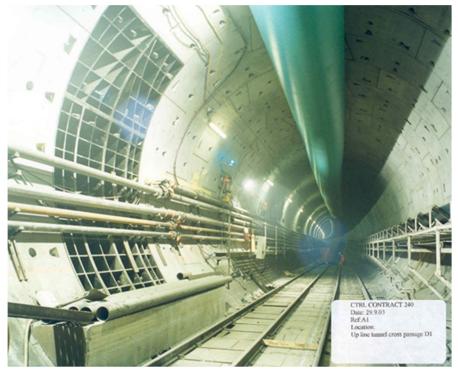
Figure A10.6: CTRL (HS1) running tunnel showing cross passage provision

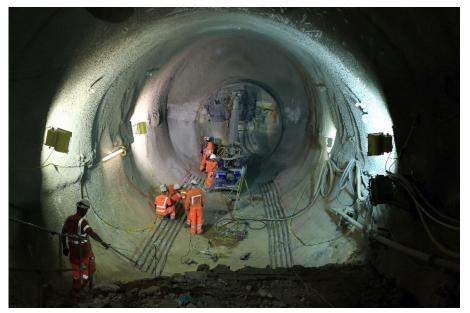
Figure A10.7: Bond Street Station Upgrade below ground works

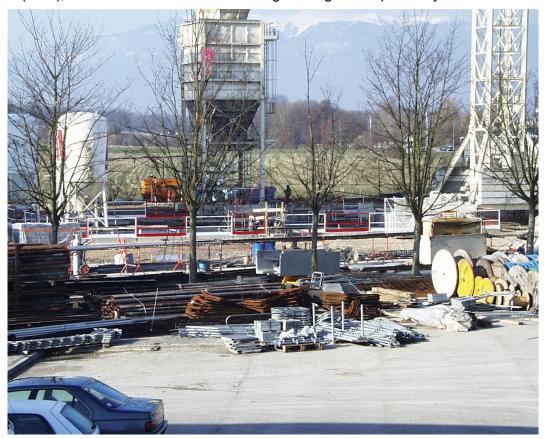
This was a project in connection with the underground particle accelerator ring. It comprised a mixture of tunnelling, earthworks, buildings and facilities. The contractor was a Joint venture between, Taylor Woodrow, AMEC and Spie Batignolles. Clients Engineer was Kellogg Brown & Root (KBR), and the Client had their own engineering and supervisory staff.

Figure A10.10: CERN Main Street Shaft
